A JOURNAL OF HIGHWAY RESEARCH

UNITED STATES DEPARTMENT OF AGRICULTURE
BUREAU OF PUBLIC ROADS

VOL. 14, NO. 1

Page Tar Surface Treatment of Low Cost Roads

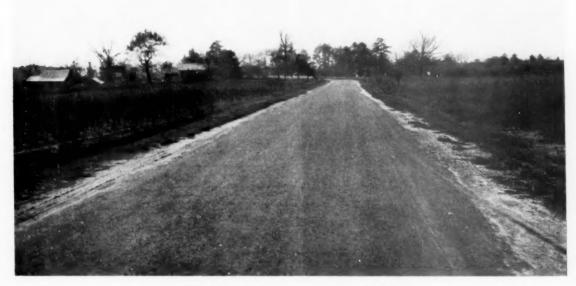
A TAR-TREATED SURFACE IN GOOD CONDITION

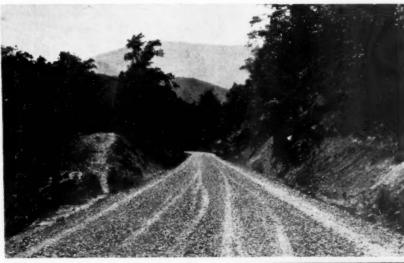
LOOSE AGGREGATE ON SURFACE OF BASE DISTRIBUTED AND ROLLED IN PREPARATION FOR APPLICA-TION OF PRIMER

LOOSE AGGREGATE BLADED UNI-FORMLY AND READY FOR APPLICA-TION OF PRIMER

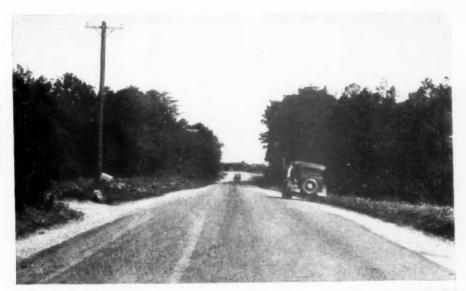
SURFACE TREATMENT BUILT OVER LOOSE SAND-GRAVEL BASE. SURFACE CONDI-TIONS ARE TYPICAL OF THOSE EXISTING ONTHIS TYPE OF ROAD

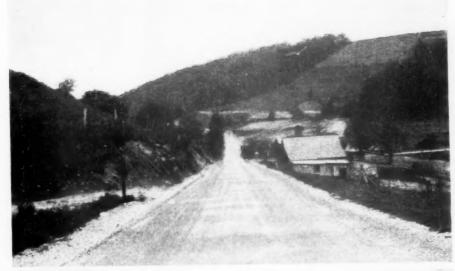
SAND-CLAY-GRAVEL ROAD FOL LOWING APPLICATION OF THE TAR PRIME COAT PRE-VIOUS TO APPLYING THE SECOND APPLICATION OF TAR

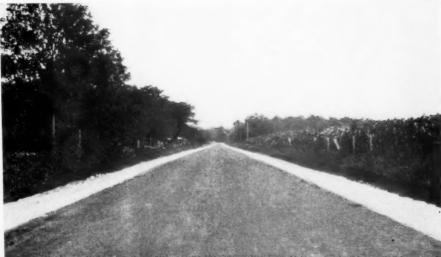
FIGURE 2. - EXAMPLES OF SURFACE TREATMENT

During cool weather the primer was heated to a temperature of 100° to 150° F. as an aid in obtaining better penetration into the base. During warm weather it was applied at a temperature of 80° to 100° F. Whenever possible, traffic was prevented from passing over the primed base for a period of 24 to 48 hours. In some cases it was necessary to prime half of the base at a time. The lower photograph of Figure 2 is typical of the appearance of a primed base prior to the second application of tar material.

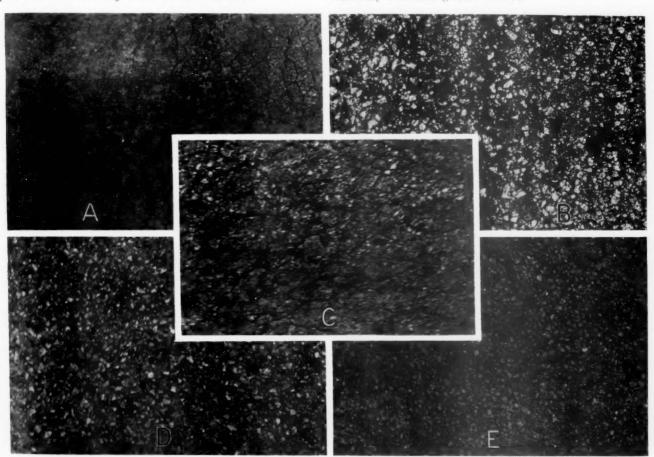
FIGURE 4.—EXAMPLES OF SURFACE TEXTURE ON TAR-TREATED PROJECTS

The type of failure occurring most frequently on the projects was a cracking of the mat, usually confined to small local areas. This type of failure occurred over bases and subgrades having high plastic properties and seemed more pronounced on projects in the coastal area, where poorer drainage conditions no doubt tended to increase the plasticity of the subgrade and base materials. Light re-treatments were generally successful in repairing areas where failures of this sort occurred. Figure 4, A is a typical illustration of such a failure.

- PROJECTS, 4 AND 5, WHERE COLD TAR MATERIALS TC-3 AND 4 WERE USED FOR SECOND APPLICATION. PHOTO SHOWS COVER STONE EMBEDDED IN THE SOFTENED PRIMED BASE RATHER THAN BEING HELD BY A TAR FILM

SURFACE CONDITION TYPICAL OF THE TWO MIXED BASE
